Manhole Inspection Summary

Manhole # S13UU_019MH

Insp Date: **8/6/07 1:25 PM**

Location Address: **DRUID PARK DR**

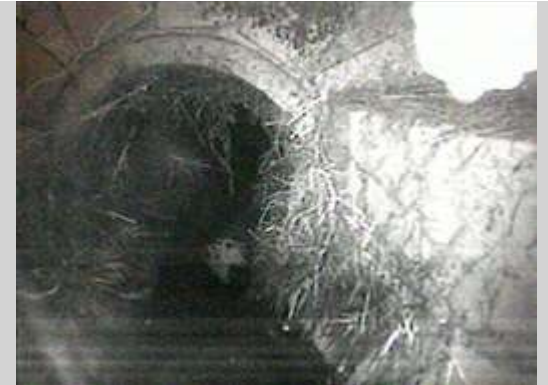
12 O'Clock Outflow

8 in. Circular Gravity Sewer
Pipe Out @ 12 O'Clock

Infiltration: **None** Pipe Seal Cond: **Roots**

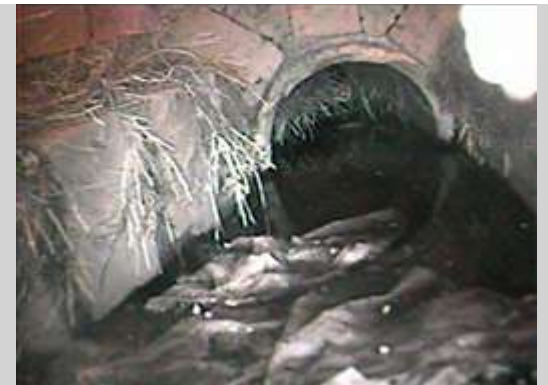
3 O'Clock Inflow

6 in. Circular Gravity Sewer
Pipe In @ 3 O'Clock

Infiltration: **None** Pipe Seal Cond: **Roots**
